Inspection Report

Minerals Regulatory Program

Mine Name: Rim/Columbus
Operator Name: Denison Mines (USA)

Permit number: M0370006
Inspection Date: July 30, 2008
Time: 10:15 AM – 12:15 PM

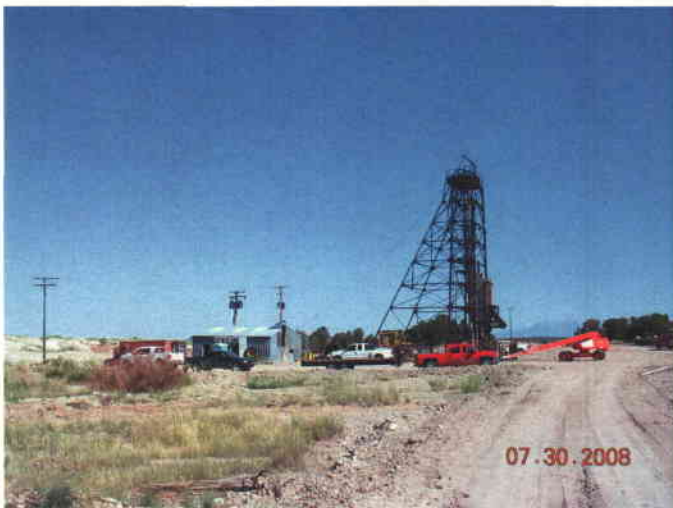
At the Rim mine, facilities include the headframe and hoist house, two water treatment ponds and a water treatment building, one waste pile, two ore pads, a pond that might be used as a sediment pond, and various power lines that have been recently upgraded (Photos 1-4).

Photo 1. An overview of part of the Rim mine disturbed area.

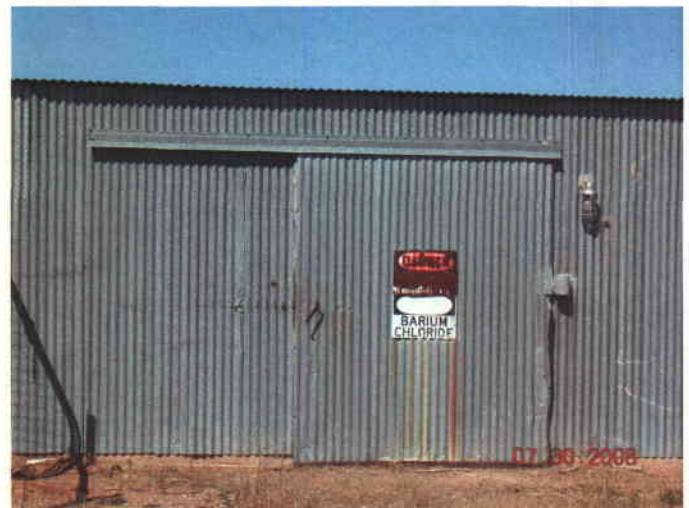
Photo 3. The water treatment building.

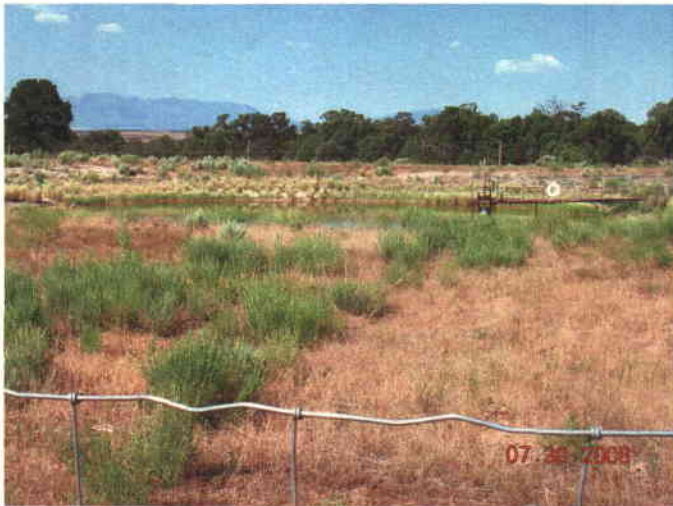
Photo 2. One of the water treatment ponds at the Rim mine.

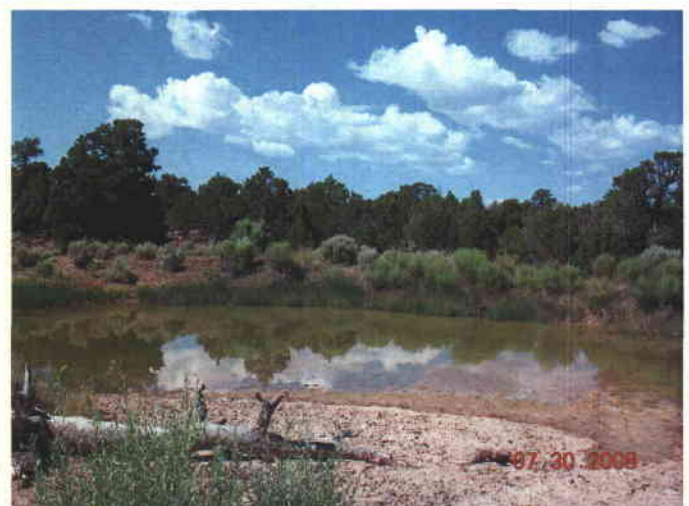
The drainage system at the Rim mine is such that most of the water is routed away from the pond below the waste rock pile (see Photos 4 and 6). The pond appears to be in an area with a natural seep, and I am not sure whether it is considered a sediment pond, a stock watering pond, or something else. Maps in the Division's file show it within the disturbed area.

Photo 4. This pond is below the waste rock pile at the Rim mine and looks like a sediment pond. There appears to be a natural seep at the pond.

I recommend that ditches at the shaft be modified so runoff would flow into the pond below the waste rock pile.

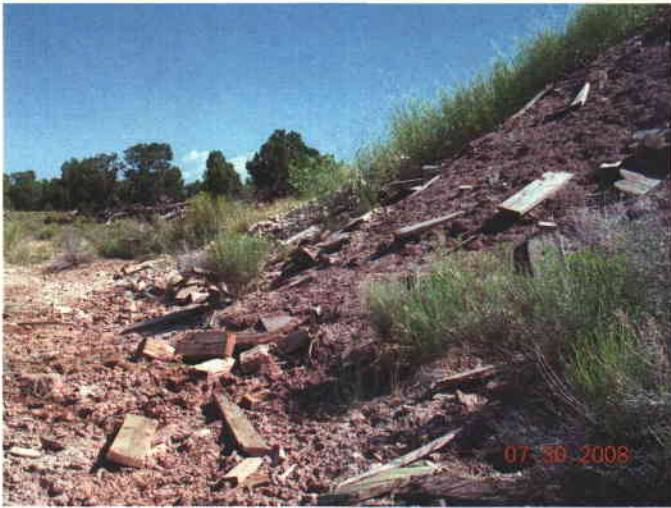
The main waste pile near the shaft has a lot of wood in it (Photo 5).

Photo 5. There is a lot of wood and other debris on the waste rock pile at the Rim mine.

Nothing except waste rock should be disposed of in the waste rock piles. Any extraneous debris, such as the wood in the pile near the shaft, should be cleaned up.

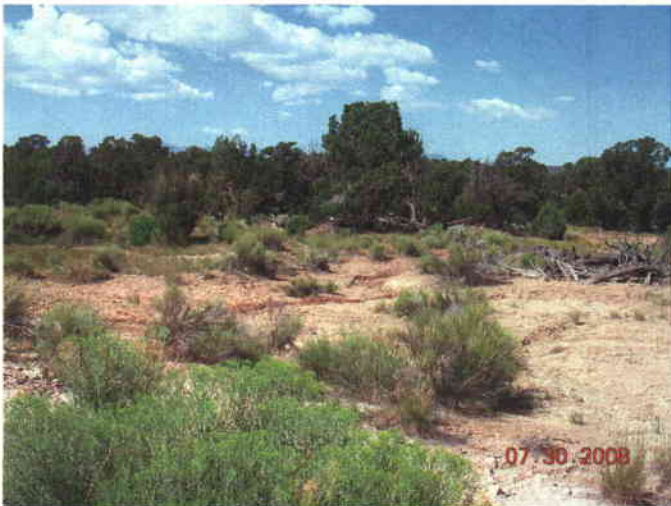
Photo 6. Runoff from most of the waste rock pile would go through the channel in the center of this pictures rather than going to the pond which is just to the left.

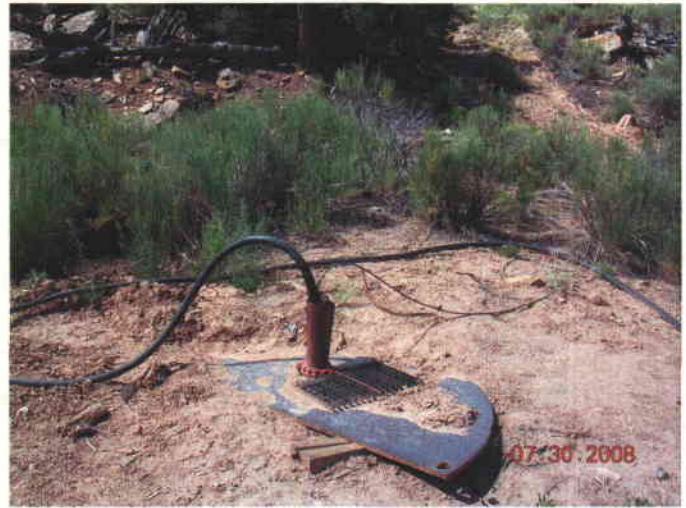
There was a power drop along the road to the Columbus and Humbug mines (Photos 7 and 8).

The borehole referred to in this letter appears to be the one being used as a power drop. The operator made the following response to the Division's comment:

Based on this information, it appears the borehole being used as a power drop is included in the reclamation bond estimate but that it is not included within the disturbed area. The operator should update maps to include the borehole in the disturbed area.

Photo 7. This is a power drop which is probably at the same location as a 20-inch borehole shown on some of the maps.

Maps of the disturbed area need to be revised, and when this happens, the operator should show revised disturbed areas reflecting use of the pads, the borehole near the Columbus mine, and any other new disturbances.

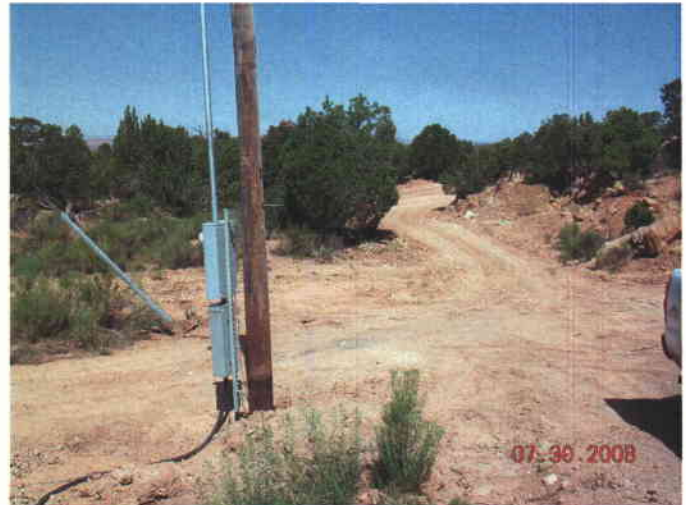
Photo 8. This shows some of the disturbed area near the power drop in Photo 7.

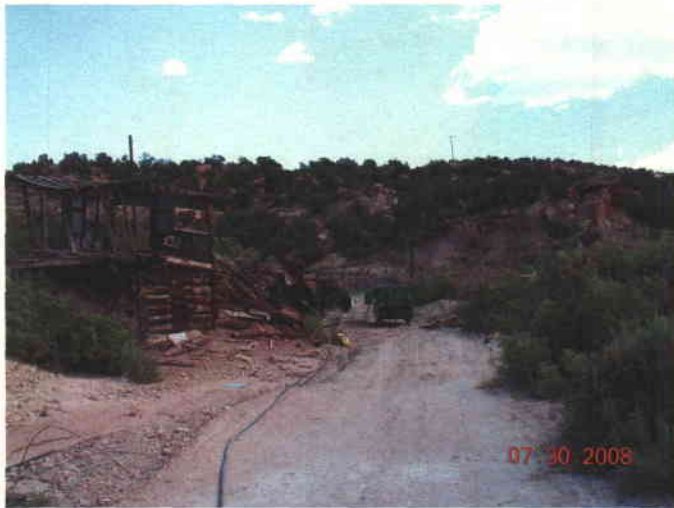
The Columbus and Humbug mines were both open, but gates had been installed so they could be closed. Other work has been done, especially at the Humbug mine, to make the areas around the portals more stable and safe (Photos 9 and 11).

Photo 9. This picture shows some of the area being used at the Columbus portal.

- The outcrops do not need to be reclaimed and are not considered part of the permitted area.
- Although the operator may disagree, reclamation at the Columbus portal should include sealing the portal and reclaiming any portions of the pad used for the mining operation.
- The pads need to be seeded, but the operator is not required to borrow topsoil to establish vegetation.

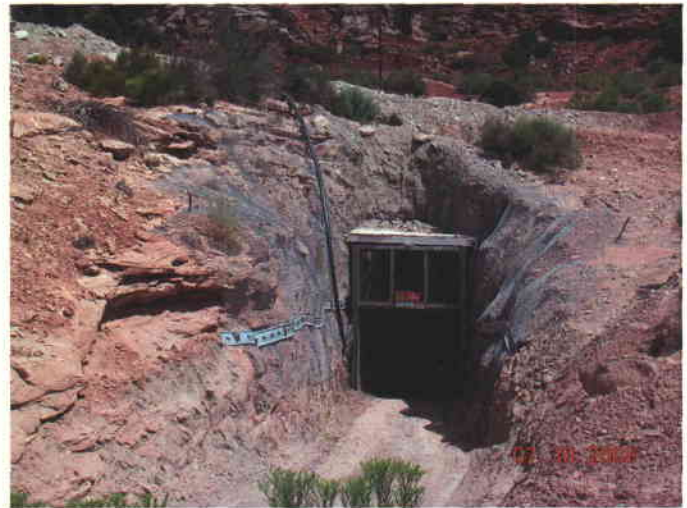
Photo 11. The Humbug portal.

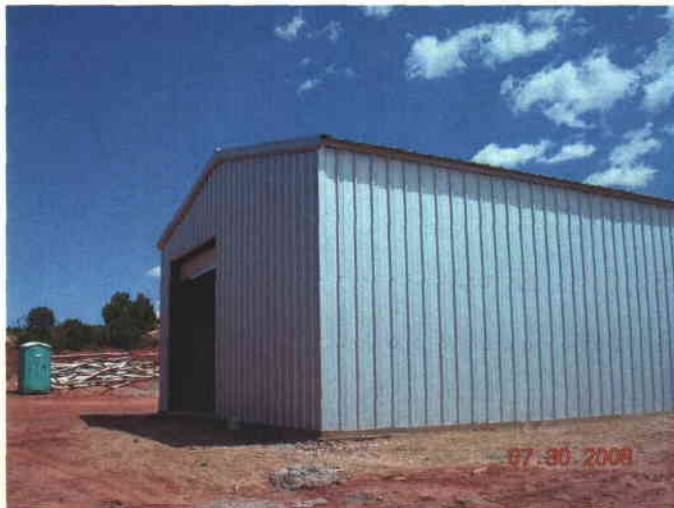
There is a new steel frame building at the Humbug mine (Photo 10). It is about 40 X 30 feet and about 20 feet high at the peak with a concrete foundation. It is off-white, and when I inspected another mine site on the opposite side of the valley, this building was very prominent.

Photo 10. A new building at the Humbug portal pad.

If the operator has a map showing the old building at the Humbug mine, it needs to be provided to the Division. If this building is not shown on existing maps, the operator needs to supply a map showing current facilities at the mine, and the bond should be updated to include reclamation of this building.

I recommend that the building be painted, perhaps dark tan, so it is not so prominent.

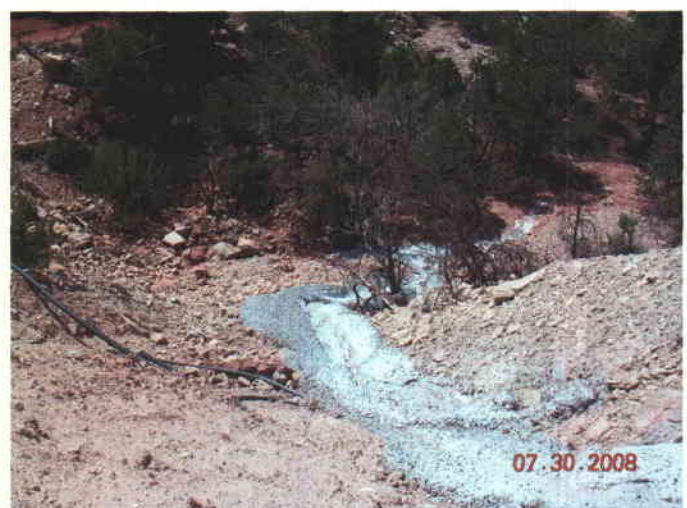
Some concrete had been disposed of on the outslope of the waste pile at the Humbug mine (Photo 12). I assume this was from when the foundation for the new building was poured. Most of the concrete was on the slope, but it appeared a small amount made it to the drainage below.

Photo 12. Concrete was dumped down the outslope of the Humbug portal pad.

The operator needs to clean up the concrete that went down the side of the waste rock pile. The outcrops of the waste rock piles are not considered to be part of the disturbed area.
